Iredell County – US 21

- Implementation Limits from Prison Camp Road to Southern Limits for the Town of Harmony
 - Completed December 13, 2008
 - Approximately 8.64 Miles
 - Part of Resurfacing
 - Before and After Observational
 - Located and Measured Ruts
 - Photo Log Documentation
 - Before – August 2008
 - After – July 2010 (~ 18 Months)
 - Cross Section 1 and 2

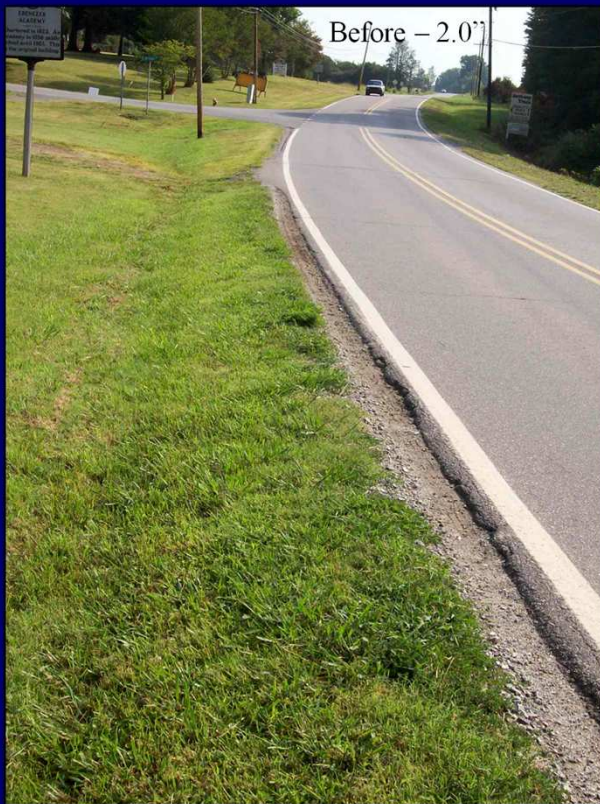
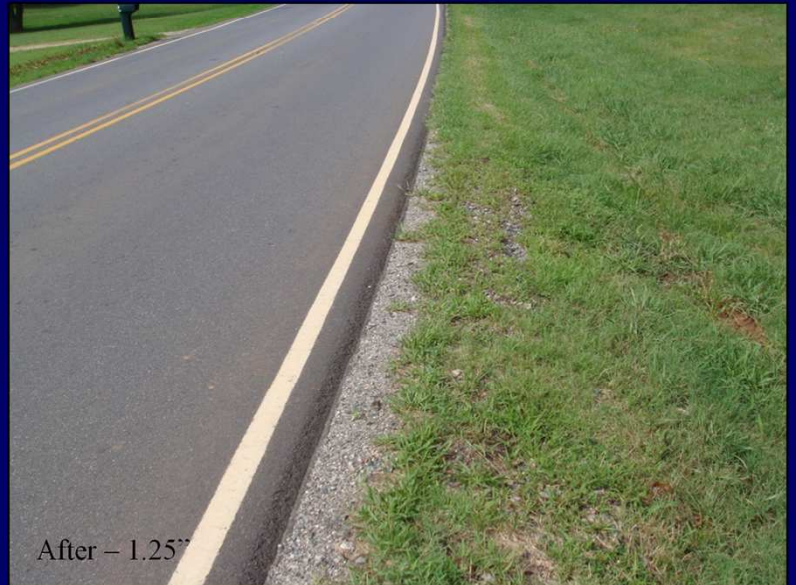
- Observation Site A

Left side is before (2.0 inch drop-off), right side is after (1.25 inch drop-off). This site re-rutted in the after period. Notice that edge is exposed in the after period and appears to be holding up to traffic.

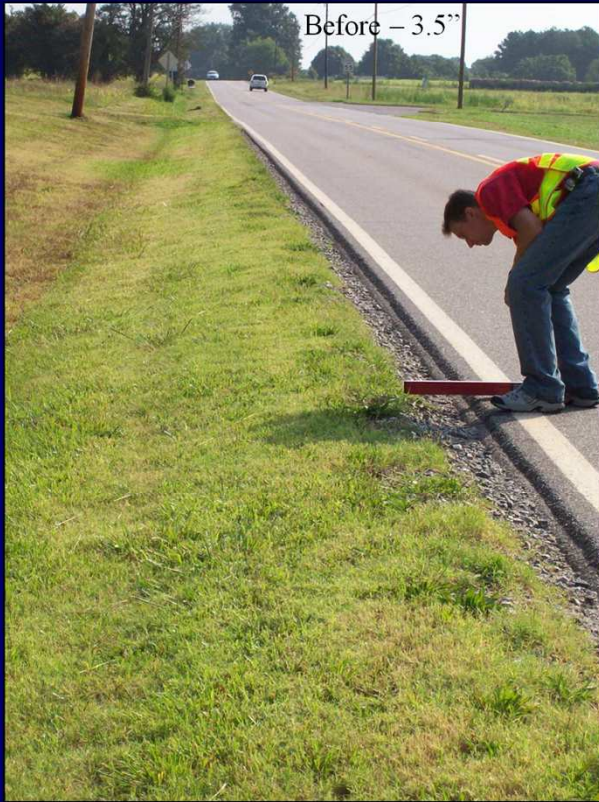
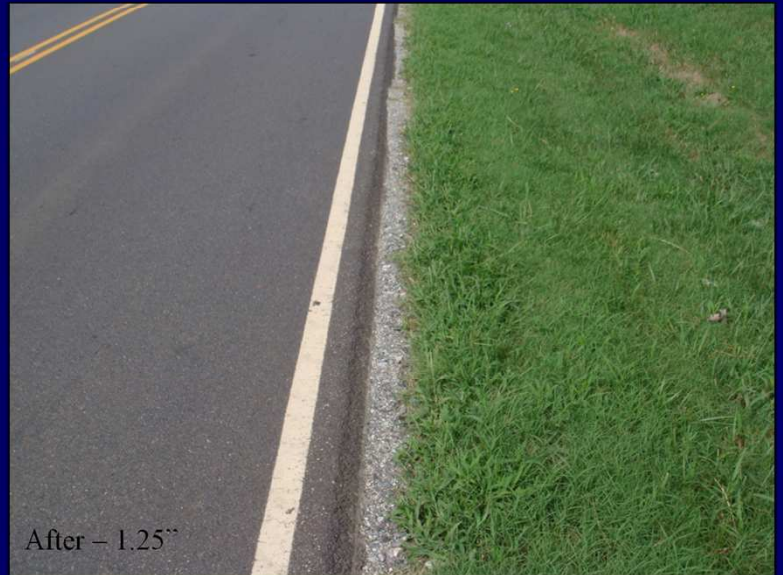
- Observation Site B

Left side is before (3.5 inch drop-off), right side is after (1.25 inch drop-off). This site re-rutted in the after period. Notice that edge is exposed in the after period and appears to be holding up to traffic.

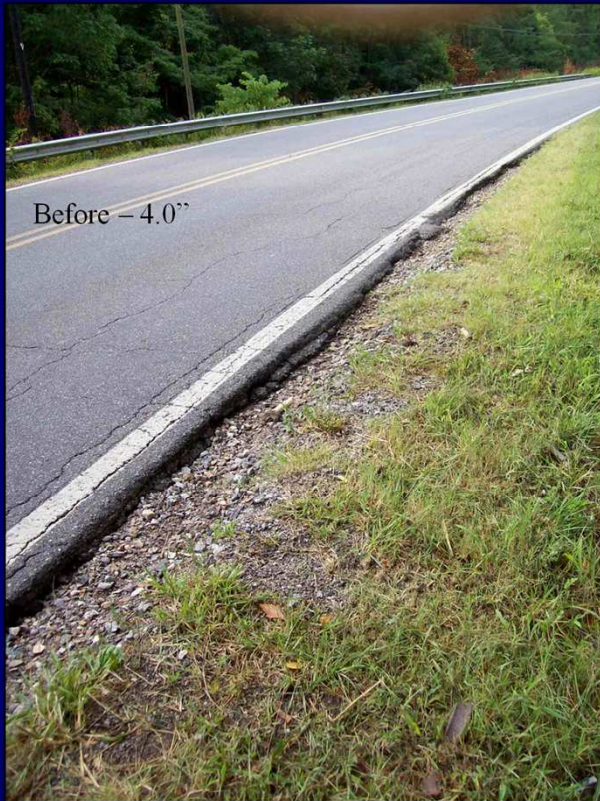
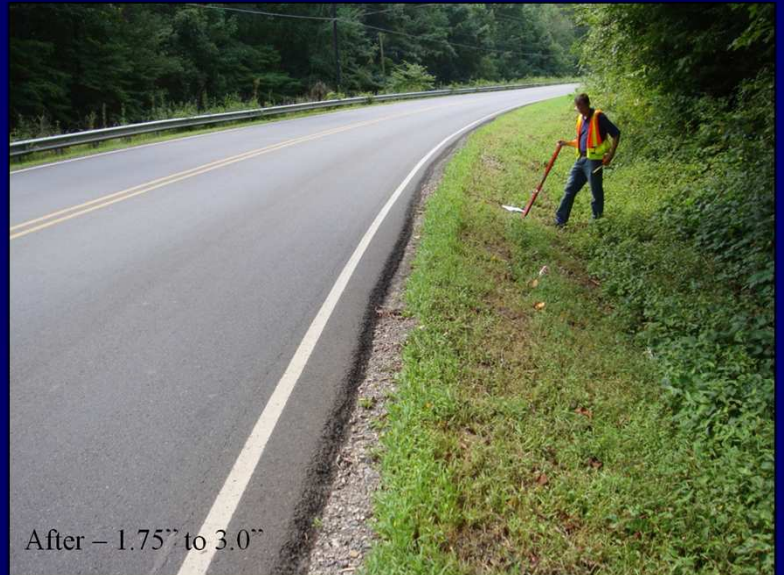
- Observation Site C

Left side is before (4.0 inch drop-off), right side is after (1.75 to 3.0 inch drop-off). This site re-rutted in the after period. Notice that edge is exposed in the after period and appears to be holding up to traffic.

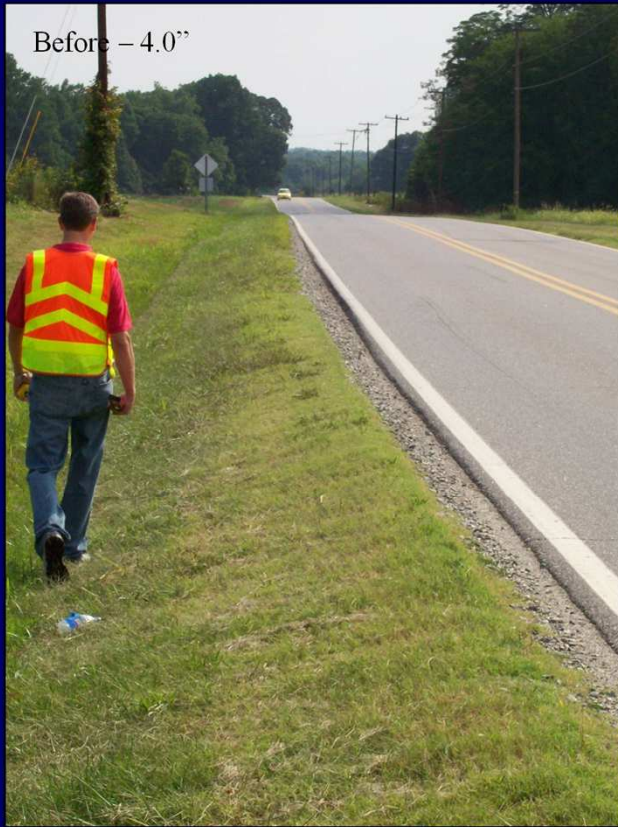
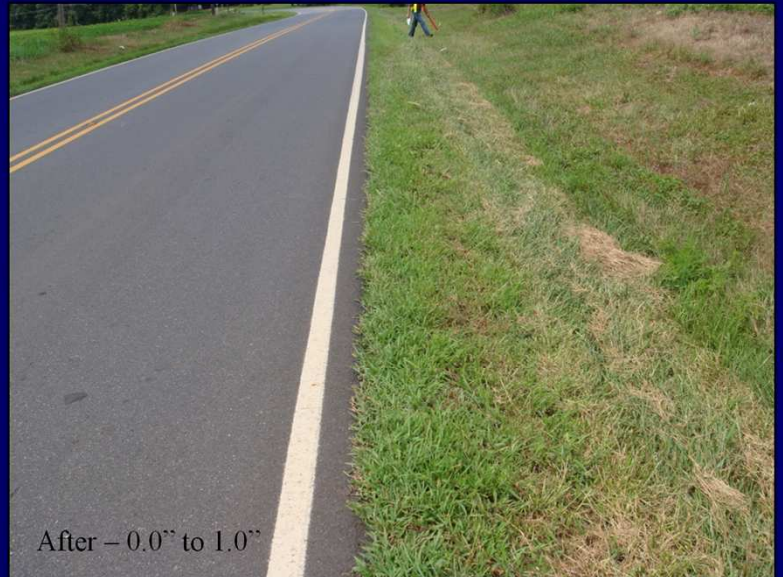
- Observation Site D

Left side is before (4.0 inch drop-off), right side is after (0.0 to 1.0 inch drop-off). This site DID NOT re-rutted in the after period. Notice that when vehicles do not run-off the road and rut out the edge, soil does stay on the 30 degree slope and grass does grow on that slope.

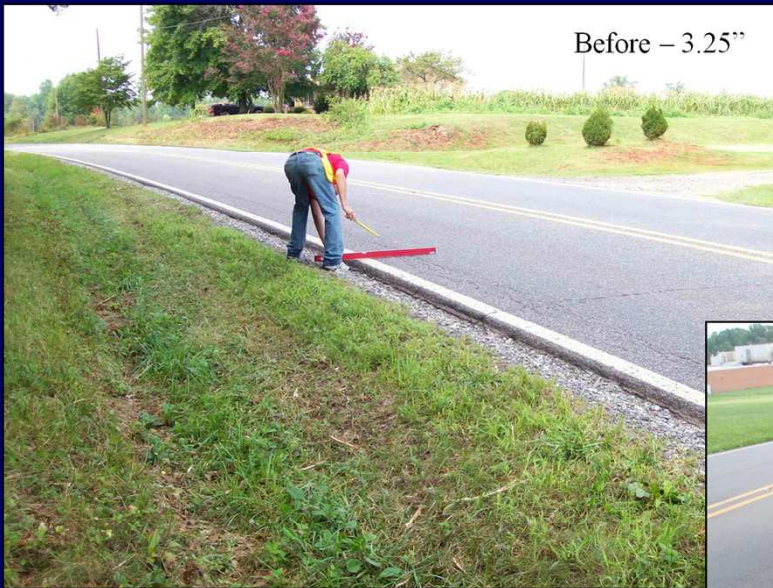
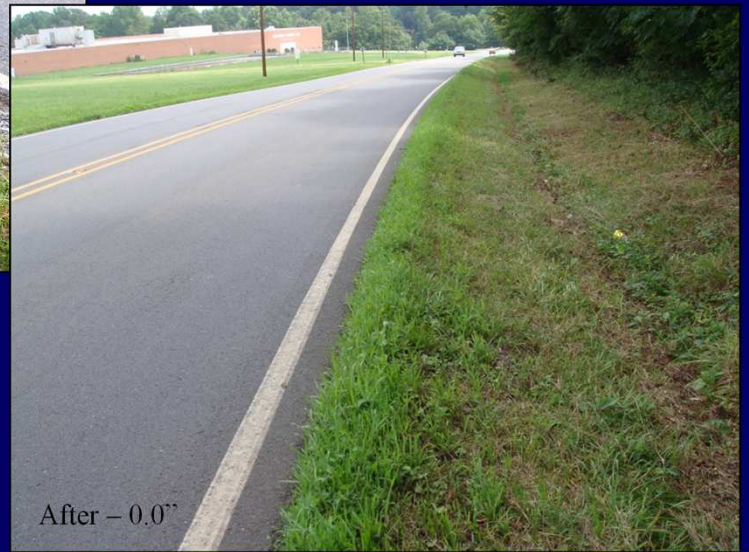
- Observation Site E

Left side is before (3.25 inch drop-off), right side is after (0.0 inch drop-off). This site DID NOT re-rutted in the after period. Notice that when vehicles do not run-off the road and rut out the edge, soil does stay on the 30 degree slope and grass does grow on that slope.

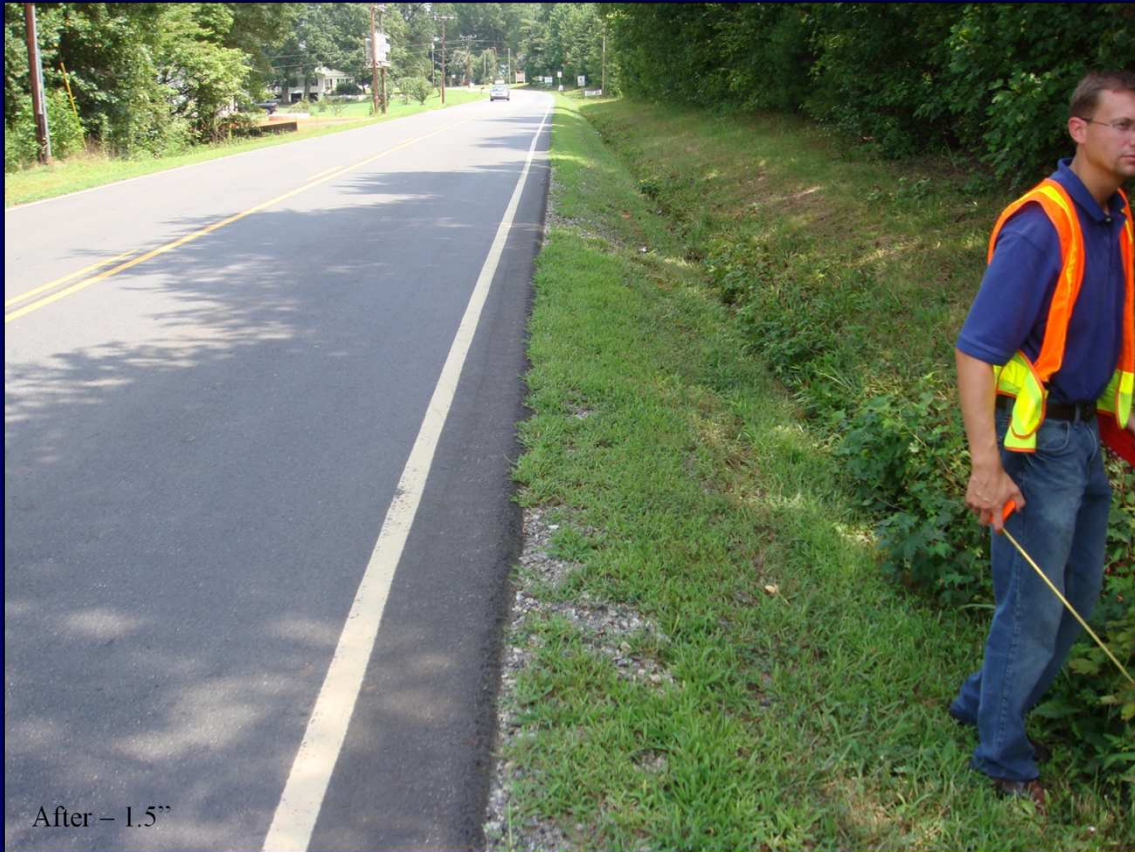
- Observation New Site A

This is a site where a rut did not exist in the before period, but a rut occurred in the after period (1.5 inch drop-off). Notice that edge is exposed in the after period and appears to be holding up to traffic.

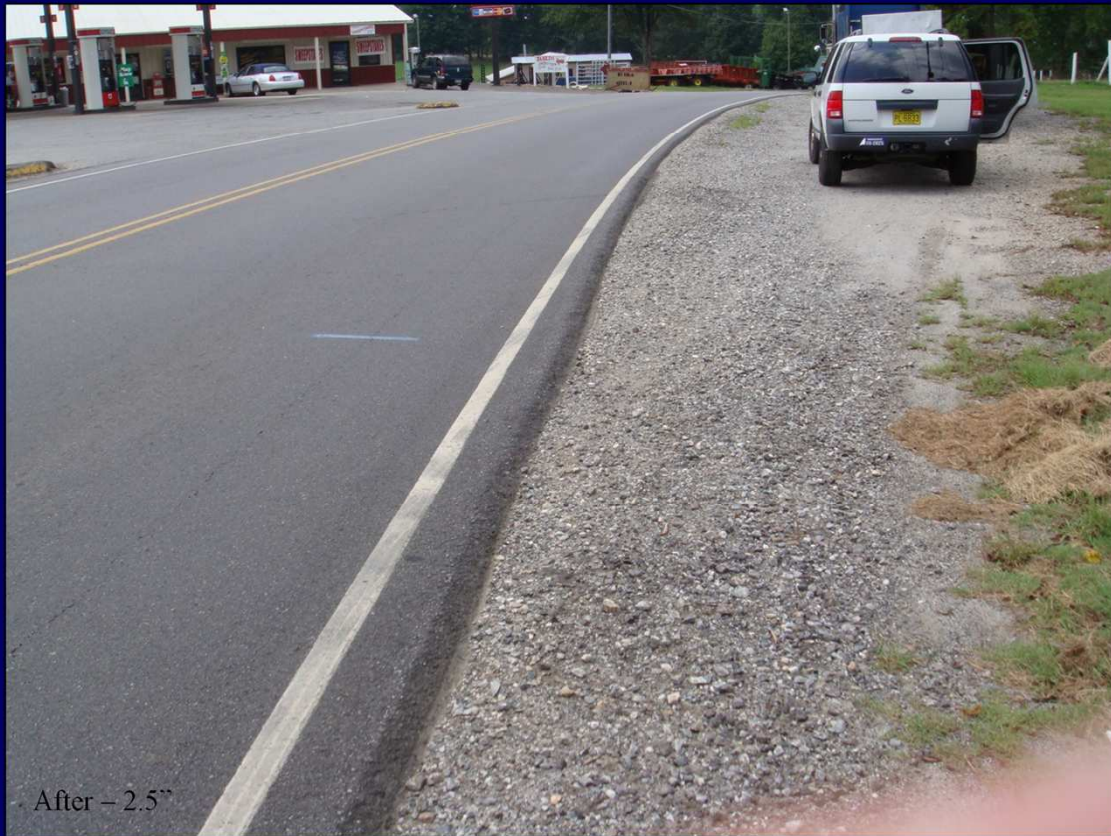
- Observation New Site B

This is a site where a rut did not exist in the before period, but a rut occurred in the after period (2.5 inch drop-off). Notice that edge is exposed in the after period and appears to be holding up to traffic. Notice the tractor-trailer parked in front of the state vehicle. This site is parking for tractor-trailers who eat at the dinner across the street. This edge is getting heavy traffic.

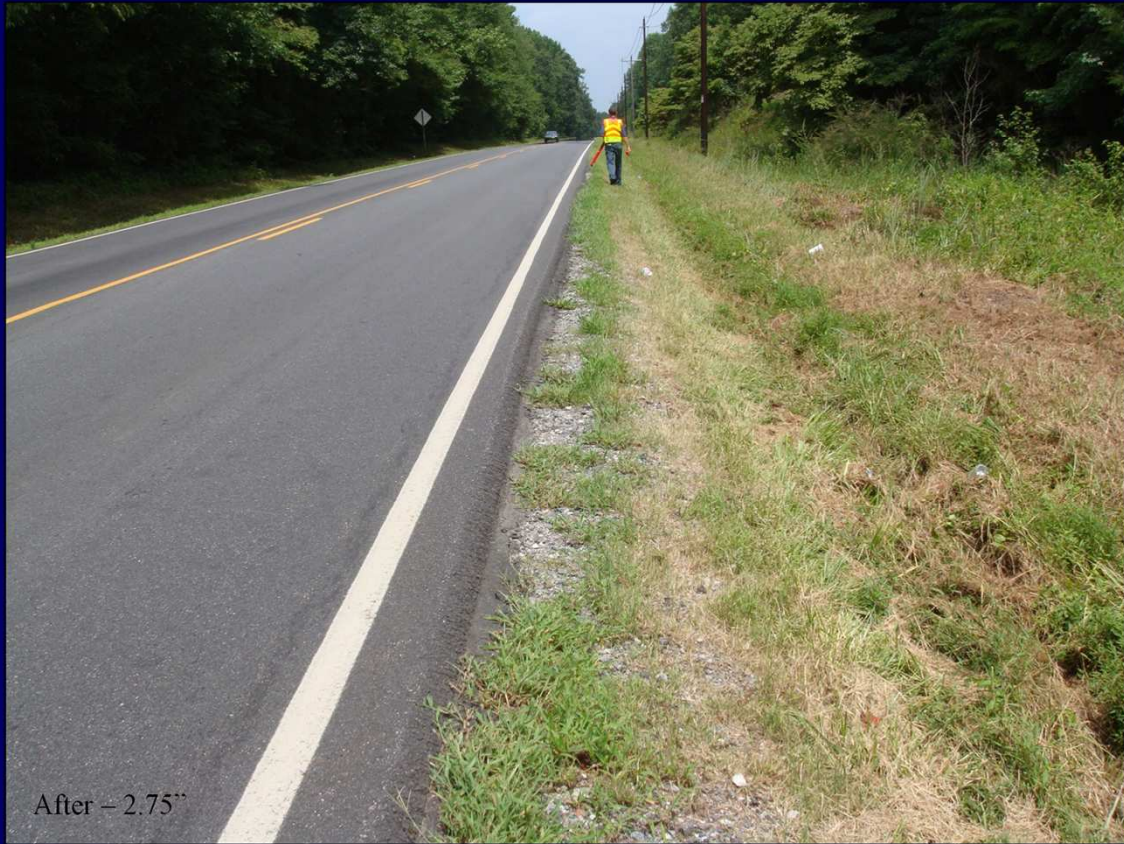
- Observation New Site C

This is a site where a rut did not exist in the before period, but a rut occurred in the after period (2.75 inch drop-off). Notice that edge is exposed in the after period and appears to be holding up to traffic.

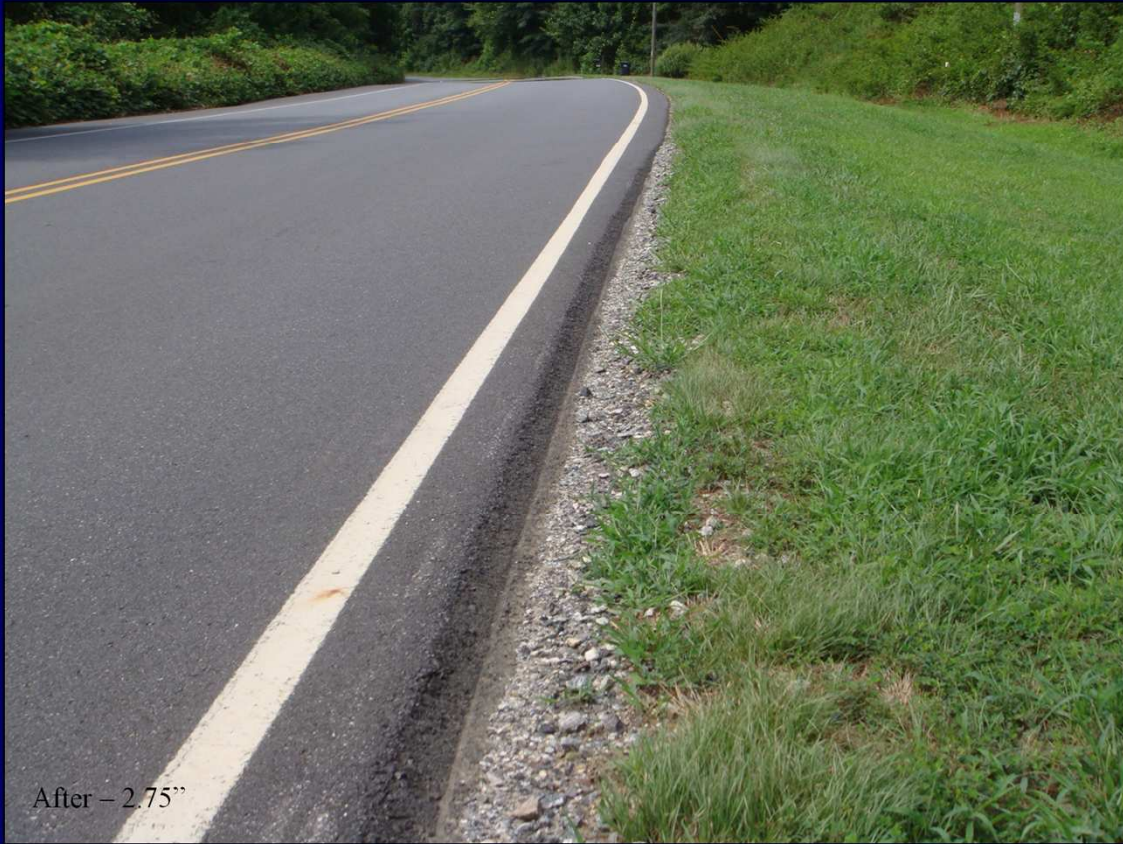
- Observation New Site D

This is a site where a rut did not exist in the before period, but a rut occurred in the after period (2.75 inch drop-off). Notice that edge is exposed in the after period and appears to be holding up to traffic.
